INSPECTION and SURVEY REPORT
of
PUBLIC SCHOOLS
FREDERICK COUNTY, MARYLAND

HELFENSTEIN & URNER, AGENTS
FREDERICK
MARYLAND

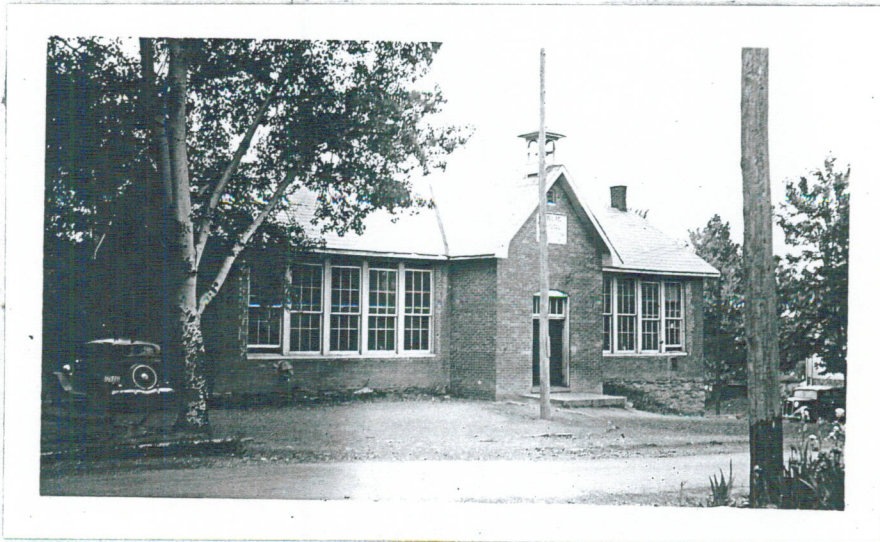
NO. 2 - POINT OF ROCKS

DESCRIPTION: One story brick building on stone foundations with ordinary wood joist roof covered with slate; interior finish is of tongued and grooved wood sheathing on ceiling, with wood lath and plaster sidewalls. Floors are of ordinary wood joist construction.

Building is quite old, but in a fair state of repair and the estimated 100% insurable value is approximately \$5,000 after deducting cost of foundations, excavations and depreciation, while at the present time \$2,700 is carried on the building and \$450 on the contents.

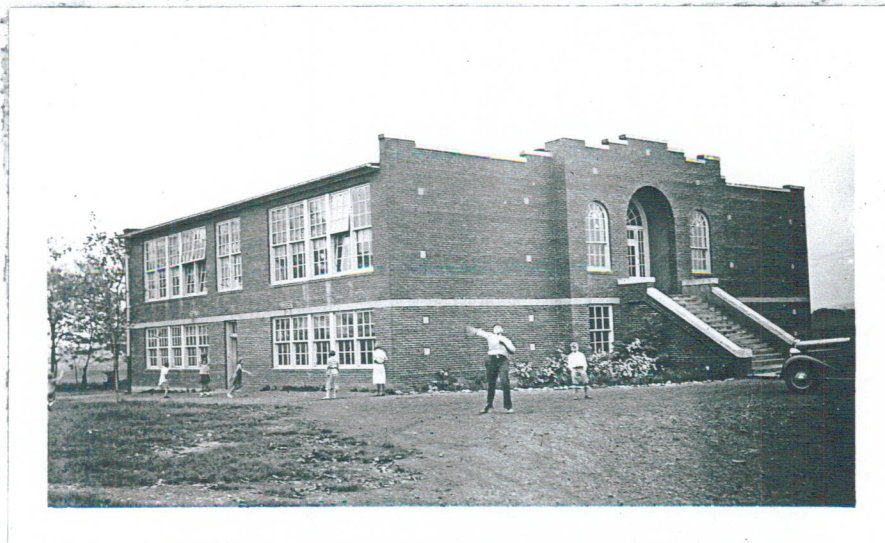
NO. 3 - ADAMSTOWN

This building was built in 1924, is in a good state of repair and the estimated 100% insurable value is approximately \$23,000 after deducting cost of foundations, excavations and depreciation, while at the present time \$18,000 is carried on the building and \$900 on contents.

FIRE PREVENTION RECOMMENDATIONS:

1. Provide two 2½ gallon chemical labelled extinguishers on each first and second floor.

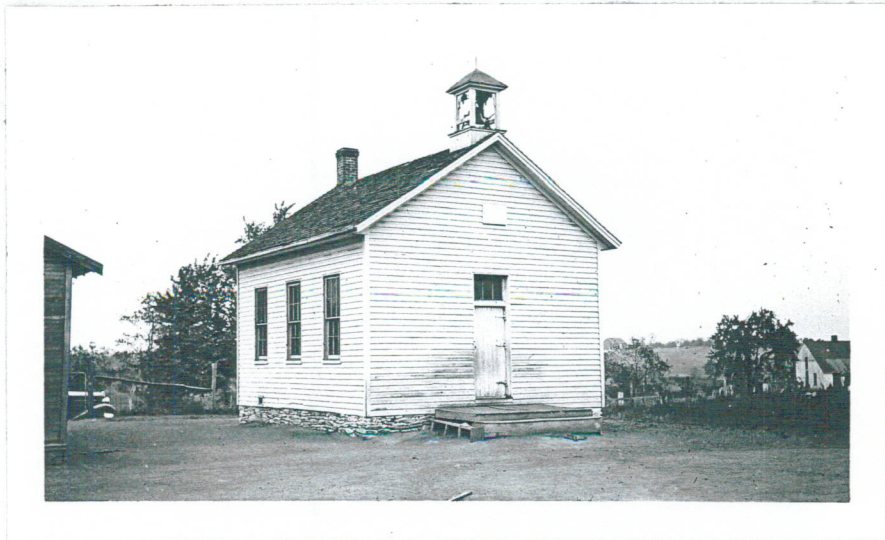
NO. 6 - PLEASANT VIEW COLORED

DESCRIPTION: One story frame building on stone foundations, with ordinary wood joist roof covered with wood shingle; the interior finish is wood-lath and plaster sidewalls, with tongued and grooved wood sheath~~ing~~ ceiling. Building apparently has not means of artificial light and is heated by stoves.

Building is quite old, in a fair state of repair and the estimated 100% insurable value is approximately \$900 after deducting cost of foundations, excavations and depreciation, while at the present time \$350 is carried on the building and \$90 on contents.

FIRE PREVENTION RECOMMENDATIONS:

1. Repair all broken lath and plaster.

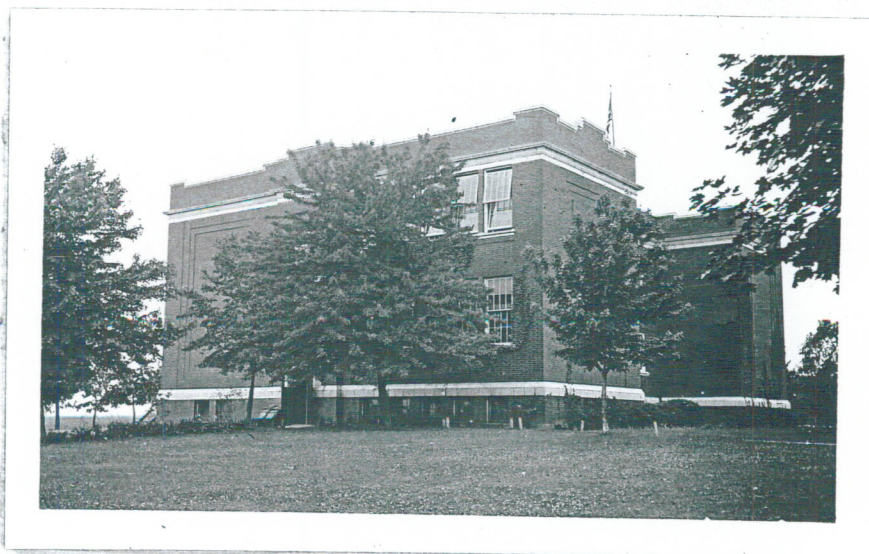
NO. 12 - CHURCH STREET

This building is old but in a good state of repair and the estimated 100% insurable value is approximately \$60,000 after deducting cost of foundations, excavations and depreciation, while at the present time \$45,000 is carried on the building and \$4,500 on contents.

FIRE PREVENTION RECOMMENDATIONS:

1. Replace all face plates that have been removed from footlight outlets on stage of auditorium.
2. Clean up and remove all rubbish and litter in athletic room.
