INSPECTION and SURVEY REPORT
of
PUBLIC SCHOOLS
FREDERICK COUNTY, MARYLAND

HELFENSTEIN & URNER, AGENTS
FREDERICK
MARYLAND

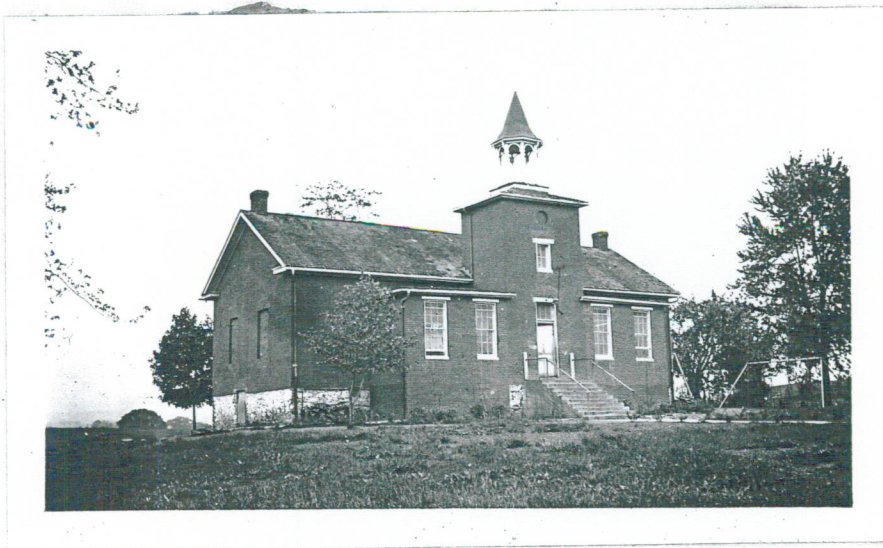
NO. 2 - POINT OF ROCKS

DESCRIPTION: One story brick building on stone foundations with ordinary wood joist roof covered with slate; interior finish is of tongued and grooved wood sheathing on ceiling, with wood lath and plaster sidewalls. Floors are of ordinary wood joist construction.

Building is quite old, but in a fair state of repair and the estimated 100% insurable value is approximately \$5,000 after deducting cost of foundations, excavations and depreciation, while at the present time \$2,700 is carried on the building and \$450 on the contents.

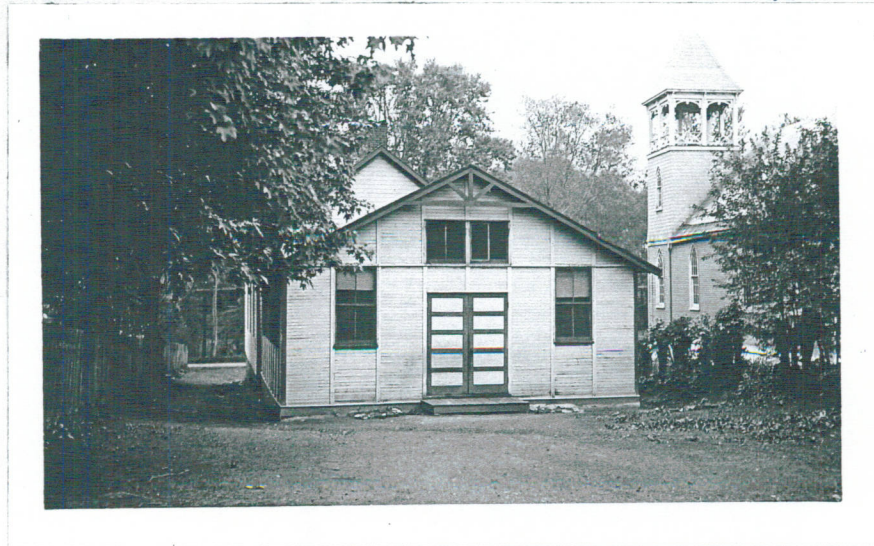
NO. 6 - PLEASANT VIEW COLORED

DESCRIPTION: One story frame building on stone foundations, with ordinary wood joist roof covered with wood shingle; the interior finish is wood-lath and plaster sidewalls, with tongued and grooved wood sheath~~ing~~ ceiling. Building apparently has not means of artificial light and is heated by stoves.

Building is quite old, in a fair state of repair and the estimated 100% insurable value is approximately \$900 after deducting cost of foundations, excavations and depreciation, while at the present time \$350 is carried on the building and \$90 on contents.

1. Repair all broken lath and plaster.

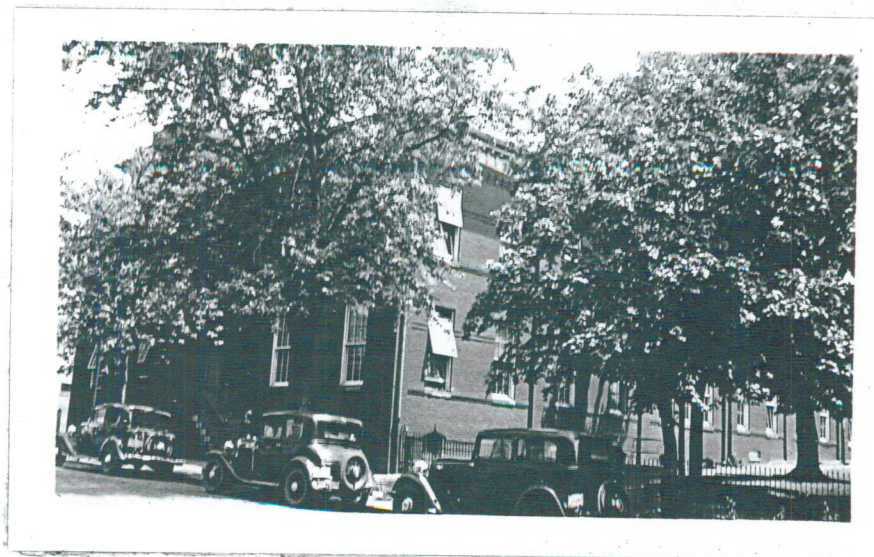
NO. 11 - WASHINGTON STREET

DESCRIPTION: Two story and basement brick building with an ordinary wood joist roof covered with slag; floors in classrooms are ordinary wood joist, with concrete floors in halls, brick division walls and concrete and steel stairs. Interior finish is wood lath and plaster, the building being lighted by electricity and heated by steam from boiler in basement.

This building apparently is only several years old and in an excellent state of repair and the estimated 100% insurable value is approximately \$55,000 after deducting cost of foundations, excavations and depreciation, while at the present time \$45,000 is carried on the building and \$3,150 on contents.

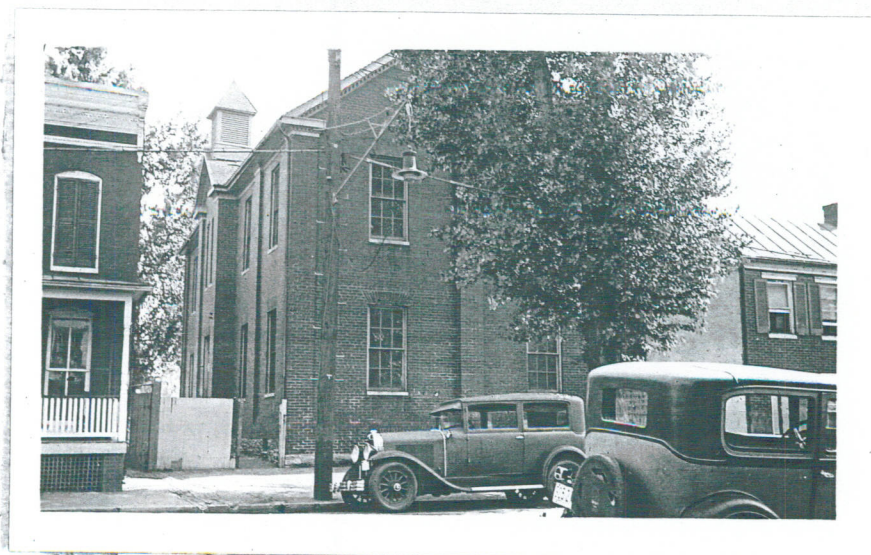
NO. 16 - SOUTH BENTZ STREET (Colored)

DESCRIPTION: One story brick building on stone foundations with ordinary wood joist roof covered with metal; interior finish of wood lath and plaster sidewalls and ceilings, with floor of ordinary wood joist construction.

This building is quite old but in a fair state of repair and the estimated 100% insurable value is approximately \$6,000 after deducting cost of foundations, excavations and depreciation, while at the present time \$6,000 is carried on the building and \$800 on contents.

DISCUSSION OF RATE: This building is rated under schedule and carries co-insurance rate of .373 on the building and .473 on contents. These rates can each be reduced 3 cents by the provision of two 2½ gallon chemical labelled extinguishers, and a further reduction of 4 cents in the contents rate by the application of the new schedule now in effect.

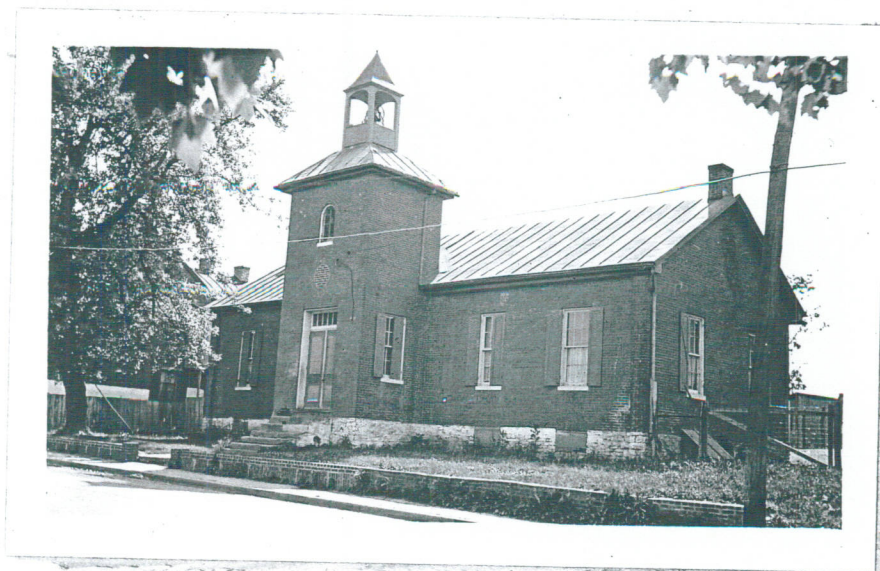
NO. 17 - MIDDLETOWN HIGH SCHOOL

DESCRIPTION: This building really consists of three sections; the southern end being two stories and basement in height, built of brick with an ordinary wood joist roof covered with slate; interior finish is of wood lath and plaster, with ordinary wood joist floors. Division walls are brick with concrete and steel stairs. Building is lighted by electricity and heated by steam from boiler in the basement.

The southern end of the building was built some years ago, while the center section and northern wing were built in 1926; the entire building is in an excellent state of repair and the estimated 100% insurable value is approximately \$90,000 after deducting cost of foundations, excavations and depreciation, while at the present time insurance is carried in the amount of \$70,000 on the building and \$5,850 on contents.

1. Repair all broken lath and plaster.
2. Clean up and remove shavings from the manual training room at the close of each day.
3. Provide chemical extinguishers as above specified.

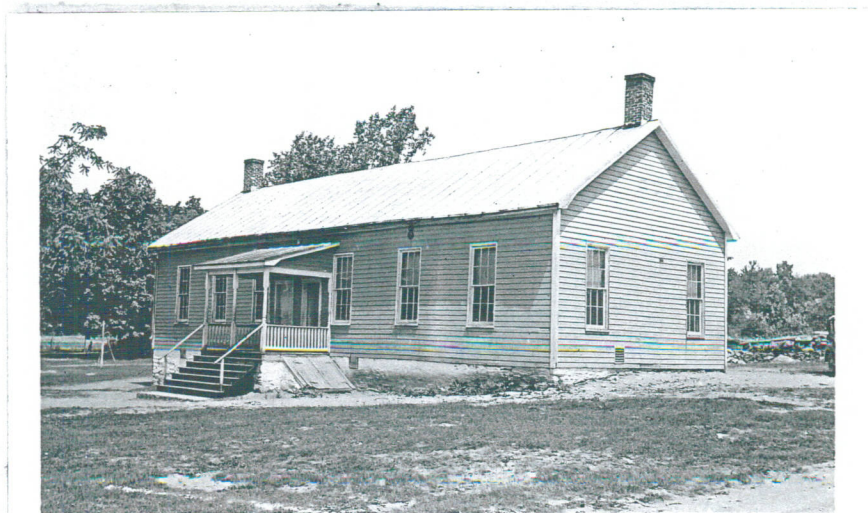
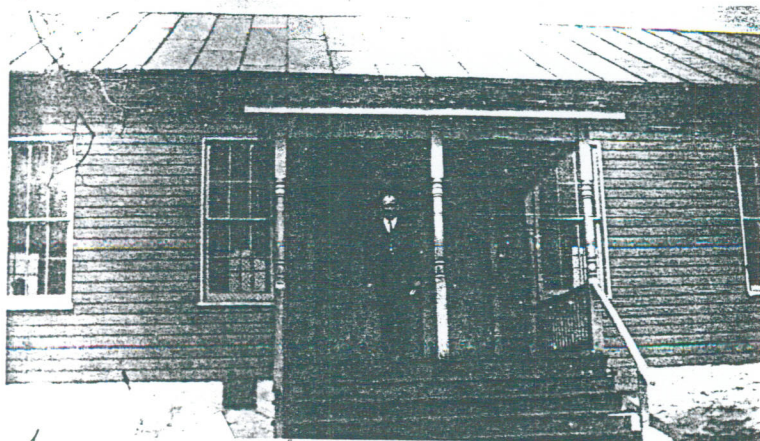
NO. 23 - WOLFVILLE

DESCRIPTION: One story and basement brick building on stone foundations, with ordinary wood joist roof covered with metal; interior finish is of wood lath and plaster sidewalls and ceiling, with floor of ordinary wood joist construction.

Building is fairly old, but in a good state of repair and the estimated 100% insurable value is approximately \$19,000 after deducting cost of foundations, excavations and depreciation, while at the present time \$7,200 is carried on the building and \$800 on contents.

1. Clean up and remove all rubbish from the coal bin in boiler room, and also from the closet under stairs.
2. Repair all broken lath and plaster.

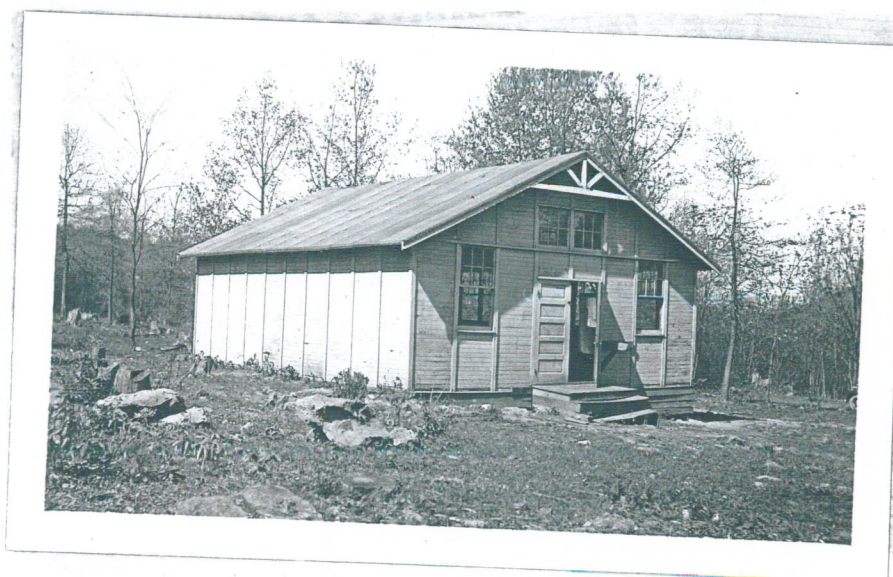
NO. 25 - URBANA

DESCRIPTION: One story and basement brick building with ordinary wood joist roof covered with slag; interior finish wood lat and plaster sidewalls, with composition board ceiling. Floor is of ordinary wood joist construction first, with concrete on earth in basement. Building is lighted by electricity and heated by steam from boiler in the basement.

Building was built in 1928, is in a good state of repair and the estimated 100% insurable value is approximately \$19,000 after deducting cost of foundations, excavations and depreciation, while at the present time \$13,500 is carried on building and \$800 on contents.

1. Provide two 2½ gallon chemical labelled extinguishers each first floor and basement.

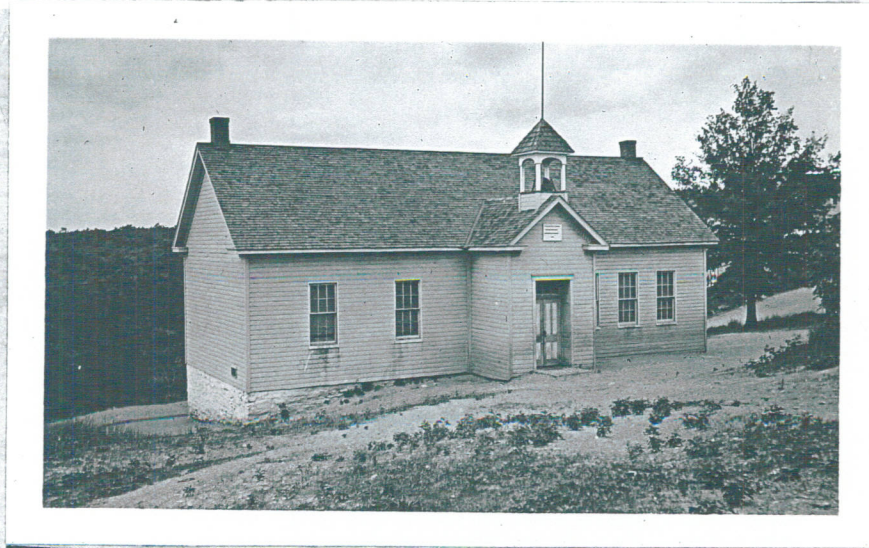
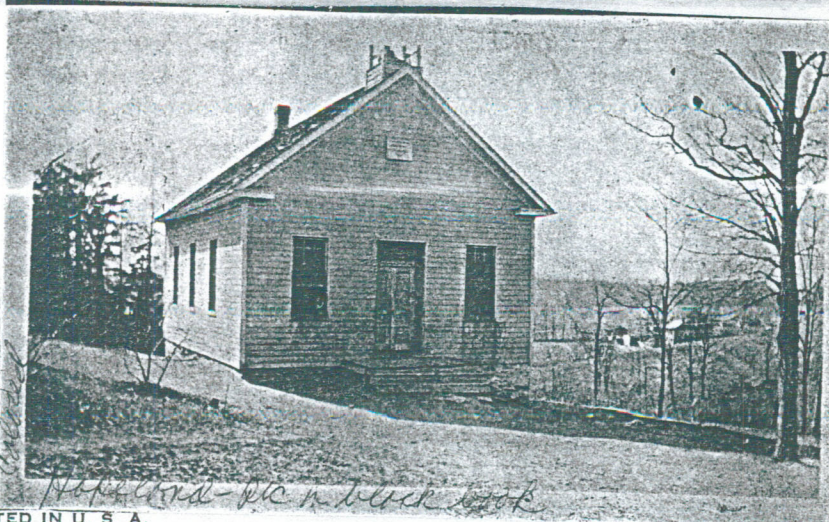
NO. 28 - EBENZER (Colored)

DESCRIPTION: One story frame building on stone foundations, with ordinary wood joist roof covered with metal; interior finish of tongued and grooved wood sheathing on ceiling, with wood lath and plaster sidewalls. Floor is of ordinary wood joist construction. Building consists of one room only, has no means of artificial light and is heated by means of coal stove with pipe running to brick chimney built from the ground. Building is fairly old, in a fair state of repair and the estimated 100% insurable value is approximately \$1,150 after deducting cost of foundations and depreciation, which at the present time \$450 is carried on building and \$90 on contents.

DISCUSSION OF RATE: This building, located in Urbana District, is outside any recognized fire protection zone and the correct rate on same therefore, should be 65 cents building and contents.

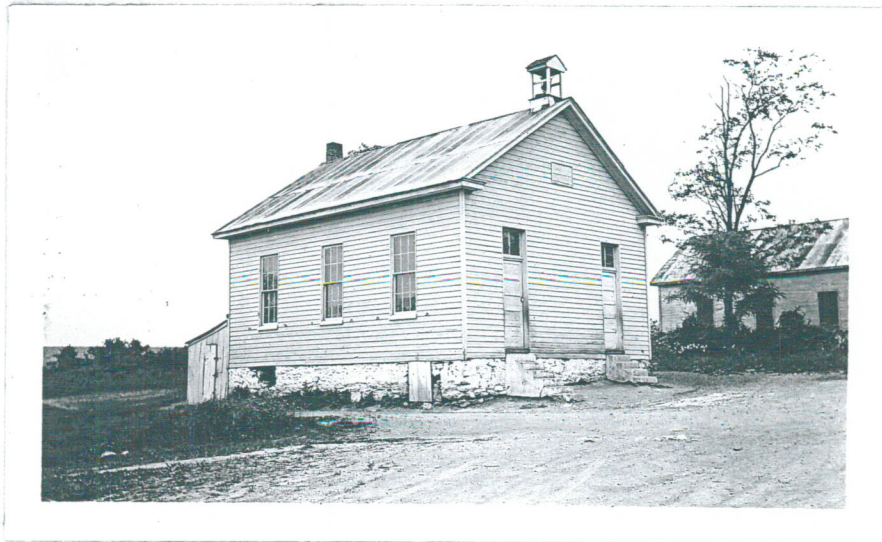
NO. 29 - DELLA (Colored)

DESCRIPTION: One story frame building on stone foundations, with woodshingle roof on ordinary wood joist; floors of ordinary wood joist construction, with an interior finish of wood lath and plaster sidewalls and ceiling. Building has no means of artificial light and is heated by means of stoves; at the time of inspection the building was entirely locked and access to the interior could not be obtained and the above information was developed from residents in the neighborhood.

Building is in a fair state of repair and the estimated 100% insurable value is approximately \$1,000 after deducting cost of foundations and depreciation, while at the present time \$450 is carried on the building and \$65 on contents.

DISCUSSION OF RATE: Building is located in the Urbana District and outside the limits of any recognized fire protection zone, and therefore, the correct rate should be 70 cents building and contents.

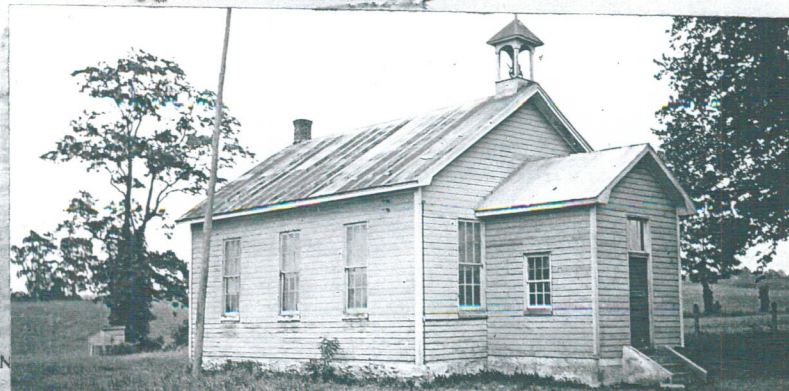
NO. 51 - LIBERTYTOWN

DESCRIPTION: Two story brick building with an ordinary wood joist roof covered with slag; division walls are brick with hallway floors of concrete, and concrete and steel stairs. Floors in classrooms being ordinary wood joist construction. Interior finish is wood lath and plaster sidewalls, with composition board ceiling. Building is lighted by electricity and heated by steam from boiler in the basement, the latter being in a separate fireproof room, cut off from the remainder of the building.

This building, building in 1927, is in a good state of repair and the estimated 100% insurable value is approximately \$45,000 after deducting cost of foundations, excavations and depreciation, while at the present time \$31,500 is carried on building and \$2,250 on contents.

1. Provide three 2½ gallon chemical labelled extinguishers on each floor.
2. Clean up and remove all rubbish in closet under stairs.
3. Footlights on stage of auditorium to be permanently installed, using either metal conduit or BX cable.

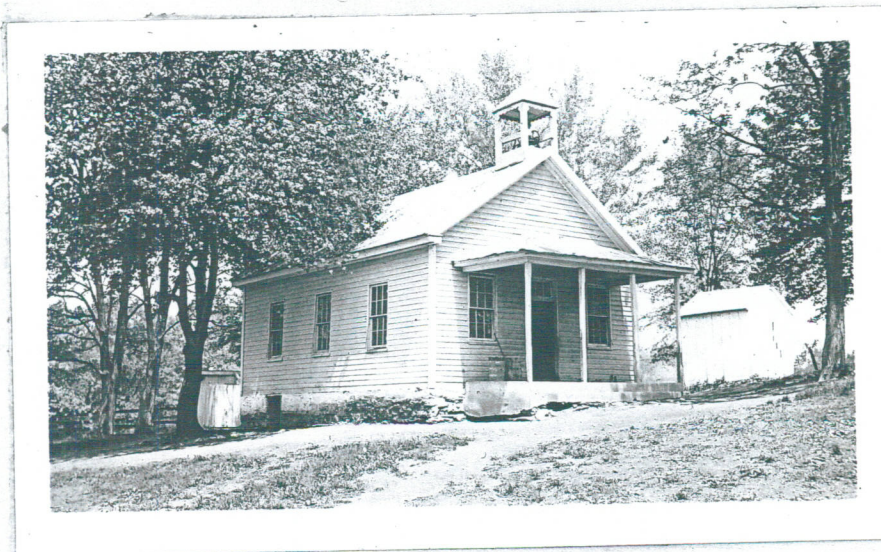
NO. 33 - LIBERTYTOWN (Colored)

DESCRIPTION: One story frame building on stone foundations, ordinary wood joist roof covered with metal; floor is ordinary wood joist, with interior finish of tongued and grooved wood sheathing on ceiling and wood lath and plaster sidewalls. At time of inspection building was locked and access to the interior could not be obtained, although we were advised that same consists of one classroom, is heated by stove with pipe running to brick chimney and has no means of artificial light. Building is in a good state of repair and the estimated 100% insurable value is approximately \$1,200 after deducting cost of foundations and depreciation, while at the present time \$450 is carried on building and \$90 on contents.

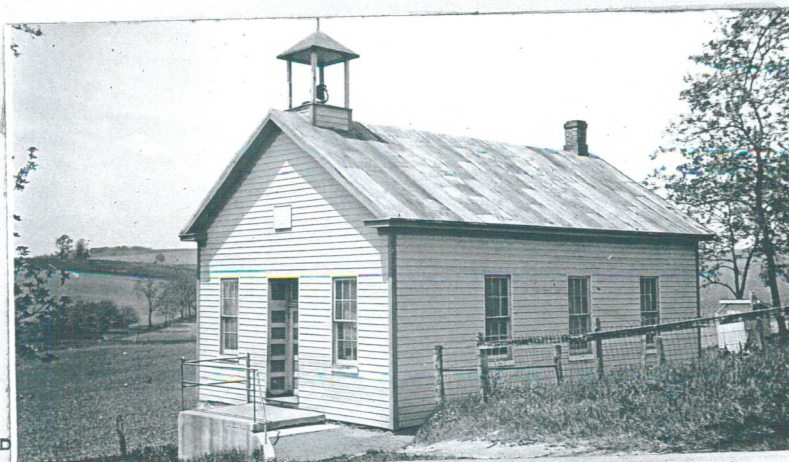
CEDAR GROVE

DESCRIPTION: One story frame building on stone foundations, with ordinary wood joist roof covered with wood shingle; floors of ordinary wood joist construction, with an interior finish of tongued and grooved wood sheathing on ceiling and wood lat and plaster sidewalls. Building is lighted by kerosene lamps and heated by stove with pipe running to brick chimney built from the ground.

This building, while owned by the School Board, is no longer used as a school but is being occupied as a dwelling and the estimated 100% insurable value, therefore, is represented by whatever amount can be obtained by the sale of the building, while at the present time insurance is being carried in the amount of \$250 on the building.

DISCUSSION OF RATES: This building, located in Libertytown District, is beyond the limits of any recognized fire protection zone and the correct rate, therefore, is 70 cents buildings and contents.

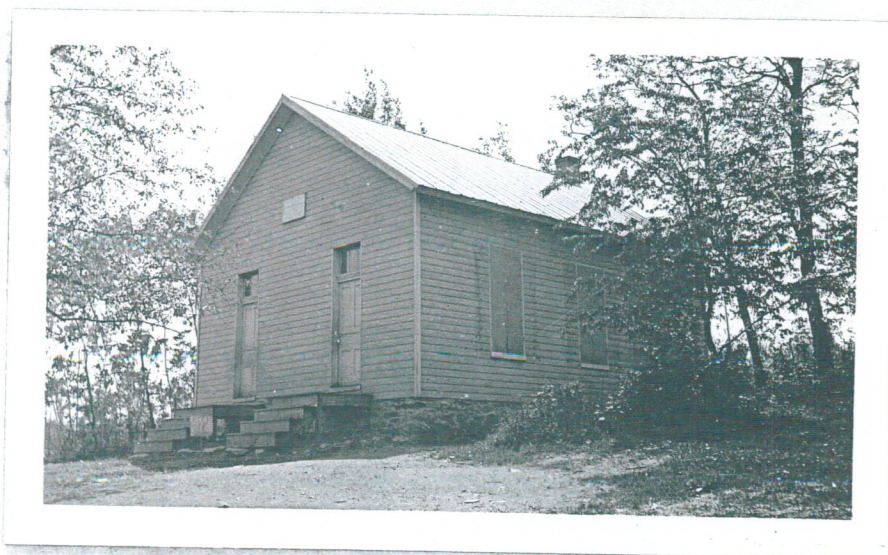
NO. 37 - NEW LONDON (COLORED)

DESCRIPTION: One story frame building on stone foundations with ordinary wood joist roofcovered with metal; interior finish is of wood lath and plaster sidewalls with tongued and grooved wood sheathed ceiling. Floor is of ordinary wood joist construction. Building consists of one classroom; there is no means of artificial light and it is heated by stove with pipe running to brick chimney.

Building is in a good state of repair and the estimated 100% insurable value is approximately \$1,000 after deducting cost of foundations and depreciation, while at the present time \$450 is carried on the building and \$90 on contents.

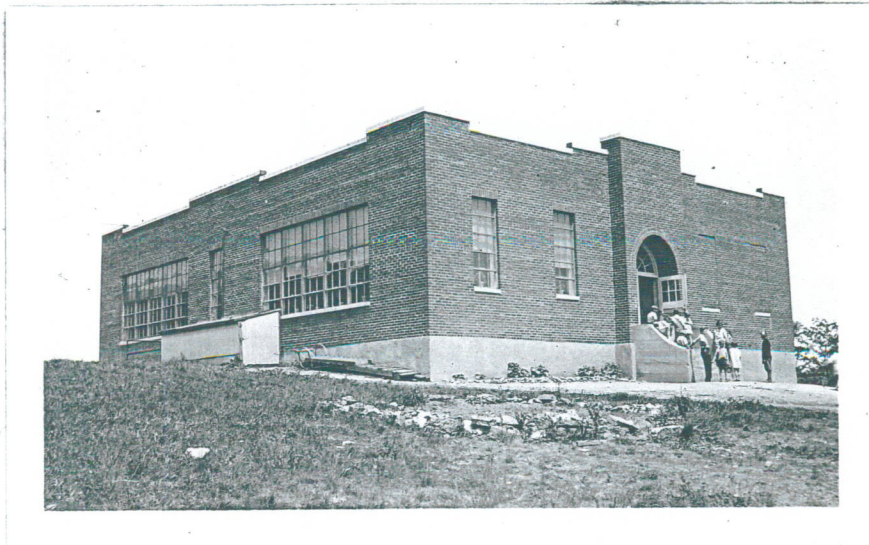
NO. 43 - MOUNT PLEASANT

DESCRIPTION: One story brick building on stone foundations with an ordinary wood joist roof covered with wood shingle; interior finish is of wood lath and plaster sidewalls, with tongued and grooved wood sheathing ceiling.

This building is fairly old but in a good state of repair and the estimated 100% insurable value is approximately \$3,000 after deducting cost of foundations and depreciation, while at the present time \$1,080 is carried on the building and \$450 on contents.

1. Provide a sheet of metal on the floor beneath all stoves, so arranged that same will extend at least 12" beyond the widest portion of the stove on all four sides.

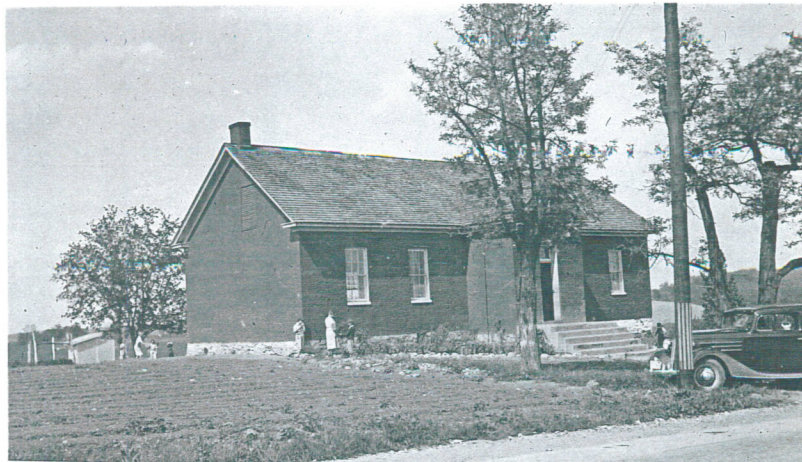
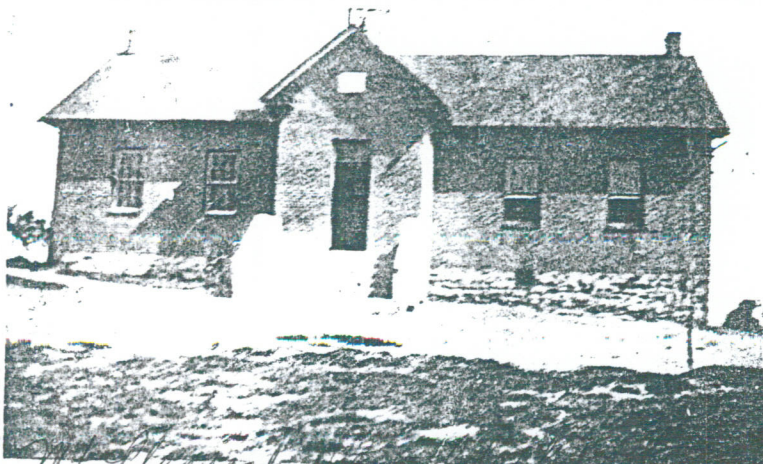
NO. 44 - MT. PLEASANT (colored)

DESCRIPTION: One story frame building on stone foundations, with metal roof on ordinary wood joist; interior finish is of wood lath and plaster, with floor of ordinary wood joist construction. This building consists of one room, lighted by kerosene lamps and heated by stove with pipe running to brick chimney built from the ground.

School is in a good state of repair and the estimated 100% insurable value is approximately \$1,000 after deducting cost of foundations and depreciation, while at the present time \$450 is carried on building and \$155 on contents.

PROTECTION: This building is located outside of any recognized fire protection zone and, therefore, the correct rate is 65 cents building and contents.

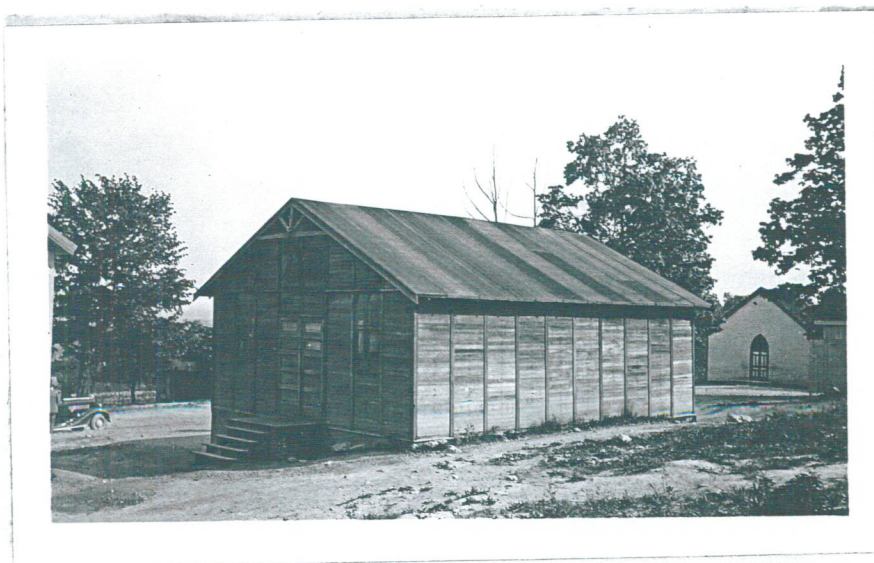
NO. 47 - SUNNYSIDE, (Colored)

DESCRIPTION: One story frame building on stone foundations, ordinary wood joist roof covered with metal; interior finish is of wood lath and plaster sidewalls with tongued and grooved wood sheathed ceiling. Floors being of ordinary wood joist construction. Building consists of one classroom, is lighted by kerosene lamps and heated by stove with pipe running to brick chimney built from the ground. Building is in a fair state of repair and the estimated 100% insurable value is approximately \$900 after deducting cost of foundations and depreciation, while at the present time \$850 is carried on building and \$90 on contents.

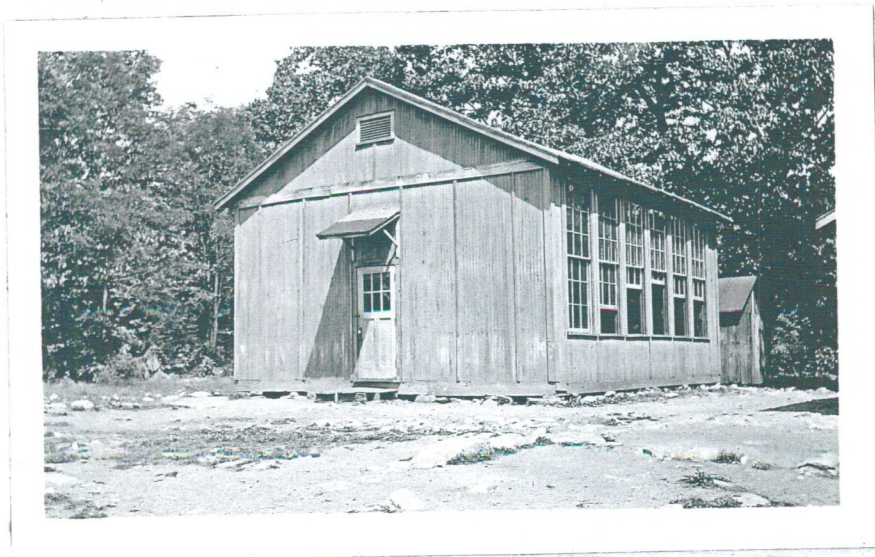
NO. 50 - CATOCHIN FURNACE

DESCRIPTION: One story frame building of the portable type with ordinary wood joist roof covered with composition; no interior finish sidewalls or ceiling, with floor of ordinary wood joist construction. This building consists of one classroom only, is lighted by kerosene lamps and heated by means of stove with pipe running to brick chimney built from the ground.

Building is in only a fair state of repair and the estimated 100% insurable value is approximately \$900 after deducting cost of foundations and depreciation, while at the present time \$575 is carried on the building and \$225 on the contents.

PROTECTION: This building is located in Thurmont District, is also beyond the limits of any recognized fire protection zone and takes a rate of 65 cents building and contents.

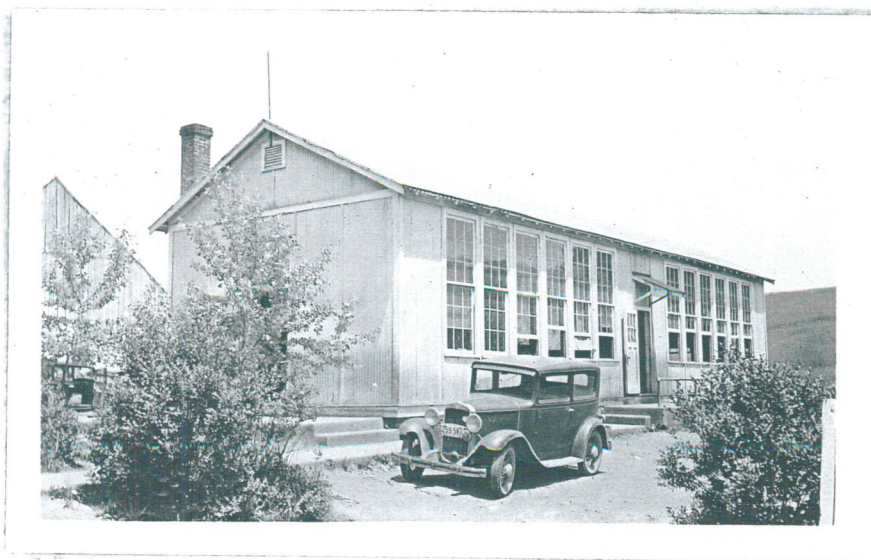
NO. 53 - JOHNSVILLE

DESCRIPTION: One story brick building on stone foundations with an ordinary wood joist roof covered with metal; interior finish is of wood lath and plaster sidewalls with tongued and grooved wood sheathed ceiling. Floor is of ordinary wood joist construction.

This school is quite old but in a good state of repair and the estimated 100% insurable value is approximately \$4,500 after deducting cost of foundations and depreciation, while at the present time \$1,350 is carried on the building and \$450 on contents.

PROTECTION: This building, located in Johnsville District, is beyond the limits of any recognized fire protection zone and the correct rate, therefore, is 58 cents building and contents.

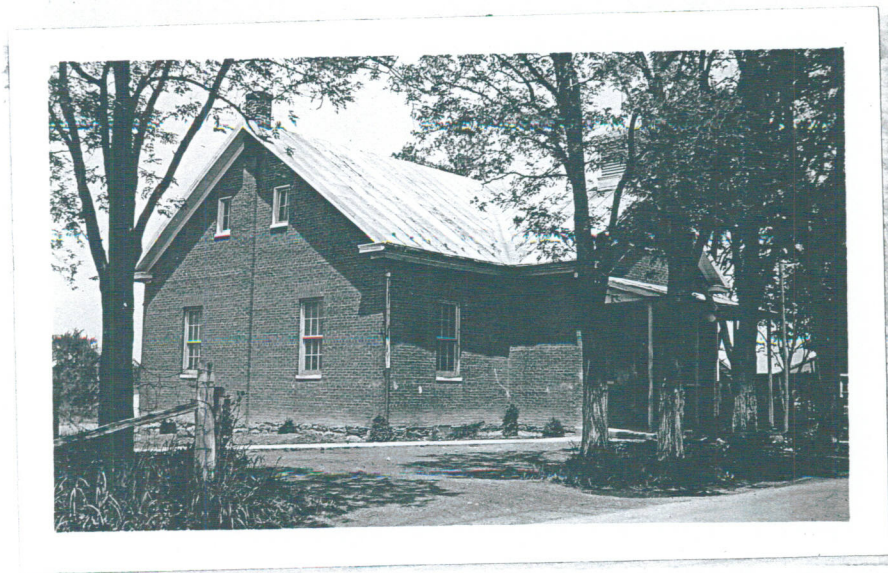
NO. 55 - FRIENDSHIP

DESCRIPTION: One story frame building on stone foundations, with ordinary wood joist roof covered with metal; interior finish is of wood lath and plaster on sidewalls with tongued and grooved wood sheathed ceiling. Building consists of one room only, is lighted by kerosene lamps and heated by stove with pipe running to brick chimney built from the ground.

Building is in a good state of repair and the estimated 100% insurable value is approximately \$1,000 after deducting cost of foundations and depreciation, while at the present time \$450 is carried on the building and \$90 on contents.

PROTECTION: This school, located in Woodville District, is outside the limits of any recognized fire protection zone and the correct rate, therefore, is 65 cents building and contents.

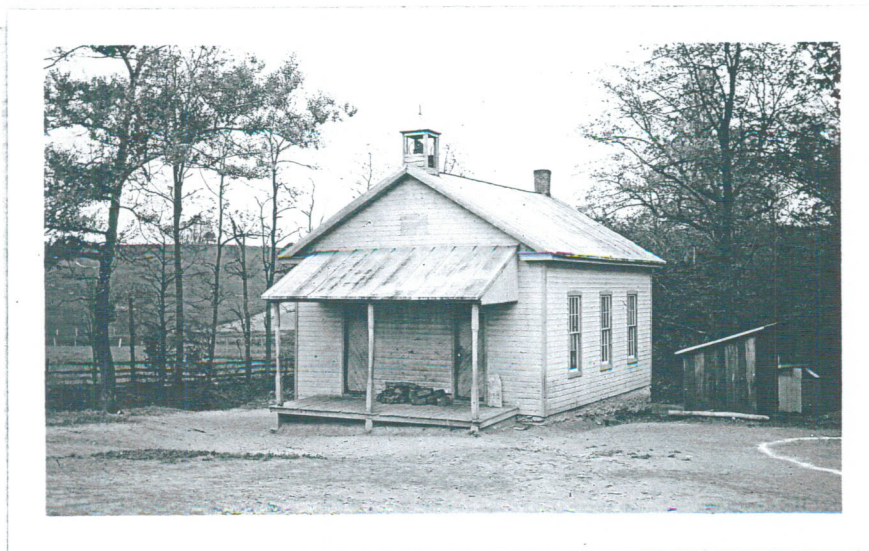
NO. 56 - FOREST GROVE

DESCRIPTION: One story frame building on stone foundations with ordinary wood joist roof covered with metal; floor is of ordinary wood joist construction, with tongued and grooved wood sheathed ceiling and sidewalls are wood lath and plaster.

This building is in a good state of repair and the estimated 100% insurable value is approximately \$1,200 after deducting cost of foundations and depreciation, while at the present time \$450 is carried on the building and \$135 on contents.

PROTECTION: This building, located in Woodville District, is outside the limits of any recognized fire protection zone and the correct rate, therefore, is 65 cents building and contents.

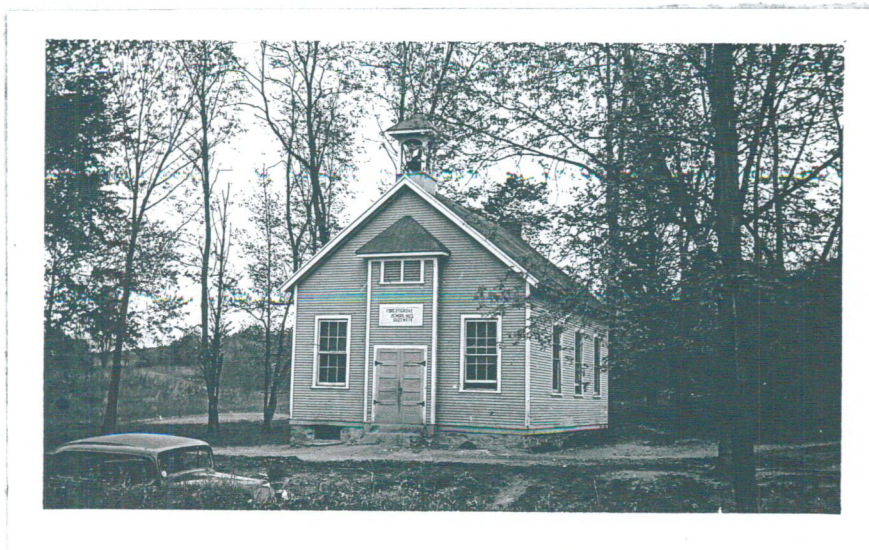
NO. 57 - PROSPECT

DESCRIPTION: One story frame building on stone foundations with ordinary wood joist roof covered with metal; interior finish is of wood lath and plaster with floor of ordinary wood joist construction.

This building is in a good state of repair and the estimated 100% insurable value is approximately \$2,000 after deducting cost of foundations, excavations and depreciation, while at the present time \$750 is carried on building and \$180 on contents.

PROTECTION: This building, located in Woodville District, is outside the limits of any recognized fire protection zone and the correct rate is 65 cents building and contents.

1. Repair all broken lath and plaster.

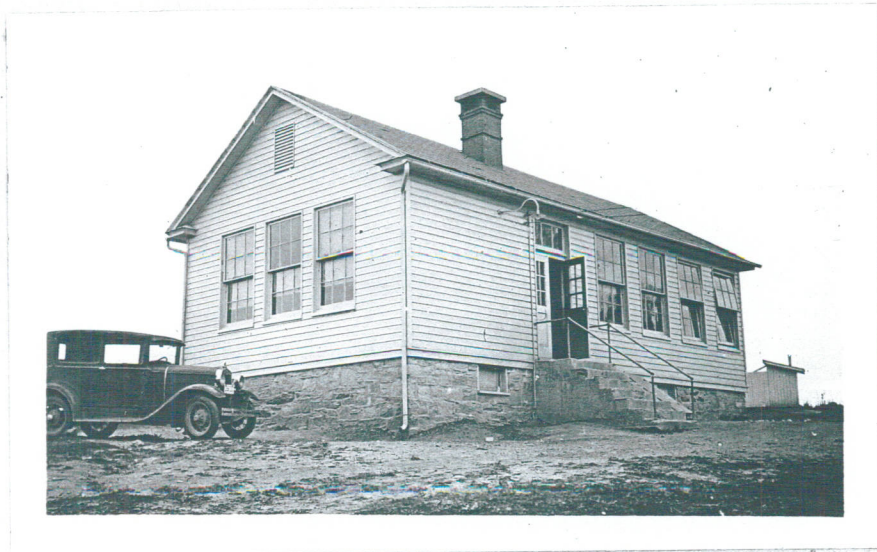
NO. 58 - HARRISVILLE

DESCRIPTION: One story frame building on stone foundations with metal roof on ordinary wood joist; floor is ordinary wood joist construction, with an interior finish of wood lath and plaster sidewalls and tongued and grooved wood sheathed ceiling.

This building apparently is quite old, in a poor state of repair and the estimated 100% insurable value is approximately \$1,000 after deducting cost of foundations and depreciation, while at the present time insurance is being carried in the amount of \$450 on building and \$135 on contents.

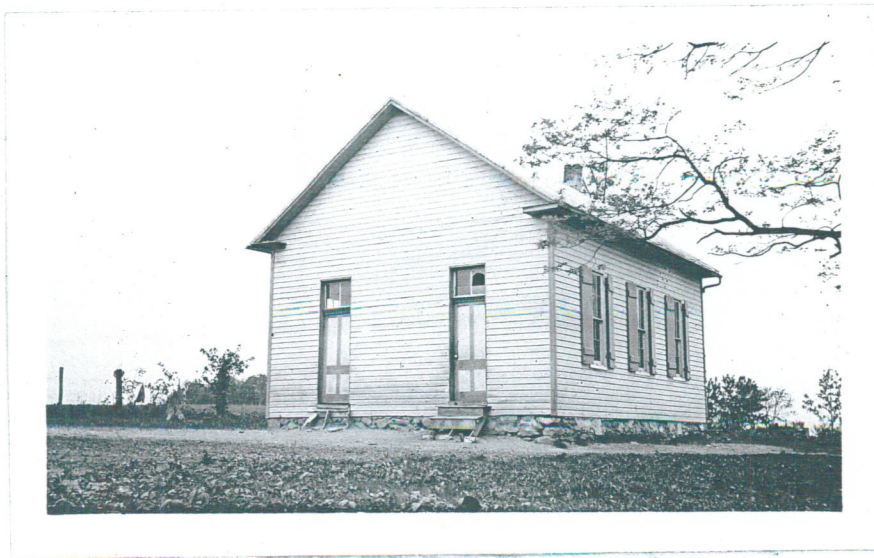
NO. 59 - UNIONVILLE

DESCRIPTION: Two story Brame building with ordinary wood joist roof covered with metal; interior finish wood lath and plaster side walls and ceiling second floor, with tongued and grooved wood sheathing first floor; floors being of ordinary wood joist construction.

This building is in a good state of repair and the estimated 100% insurable value is approximately \$4,000 after deducting cost of foundations and depreciation, while at the present time \$2,700 is carried on the building and \$450 on contents.

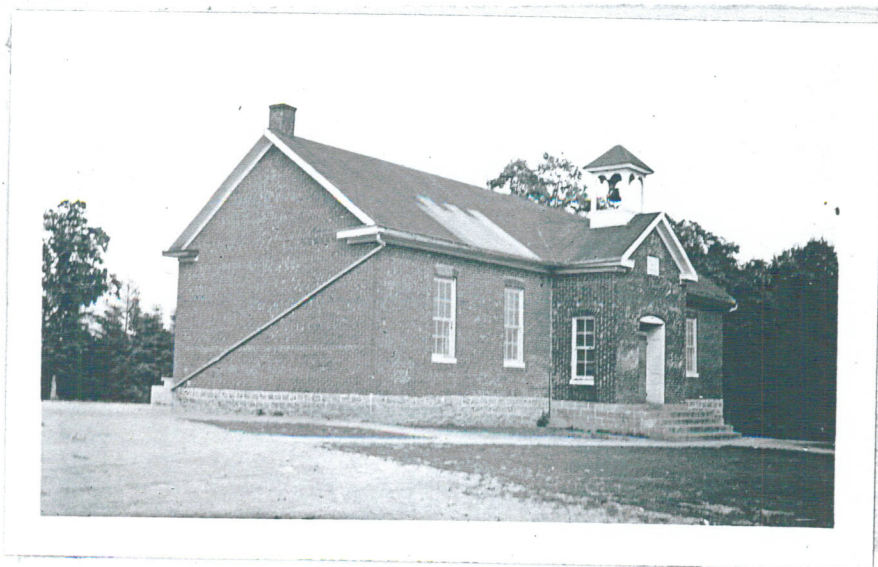
NO. 64 - BROAD RUN

DESCRIPTION: One story brick building with metal roof on ordinary wood joist; interior finish is of wood lath and plaster sidewalls and ceiling, with floor of ordinary wood joist construction.

Building is quite old, in a fair state of repair and the estimated 100% insurable value is approximately \$3,000 after deducting cost of foundations and depreciation, while at the present time \$1,125 is carried on the building and \$270 on contents.

PROTECTION: This building, located in Burkittsville District, is outside the limits of any recognized fire protection zone, and the correct rate, therefore, is 58 cents building and contents.

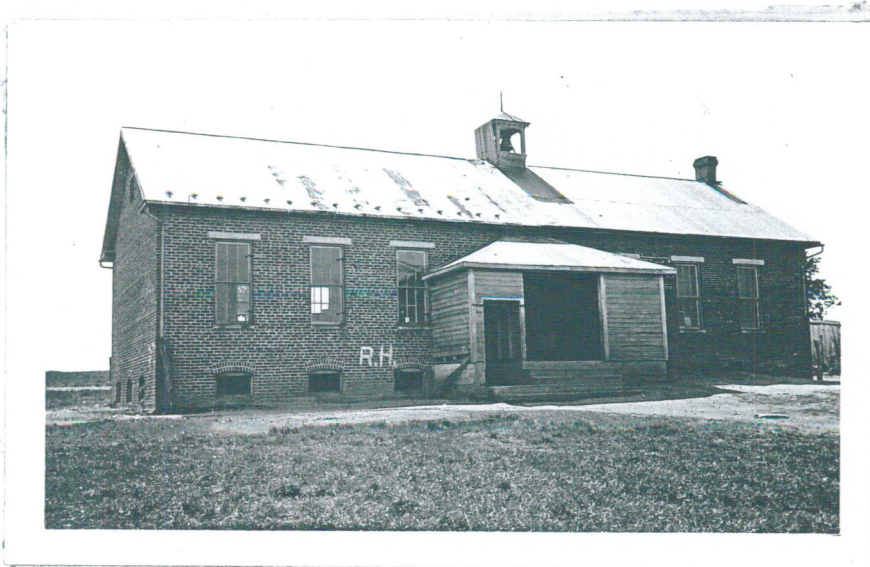
NO. 65 - BURKITTSVILLE

DESCRIPTION: One story and basement brick building with ordinary wood joist roof covered with slag; interior finish is wood lath and plaster sidewalls with pressed metal ceiling; floor is of ordinary wood joist construction.

This building, built in 1914, is in a good state of repair and the estimated 100% insurable value is approximately \$13,000 after deducting cost of foundations, excavations and depreciation, while at the present time \$6,750 is carried on the building and \$775 on contents.

1. Repair all broken lath and plaster.
2. Clean up and remove all rubbish from closet beneath the stairs.

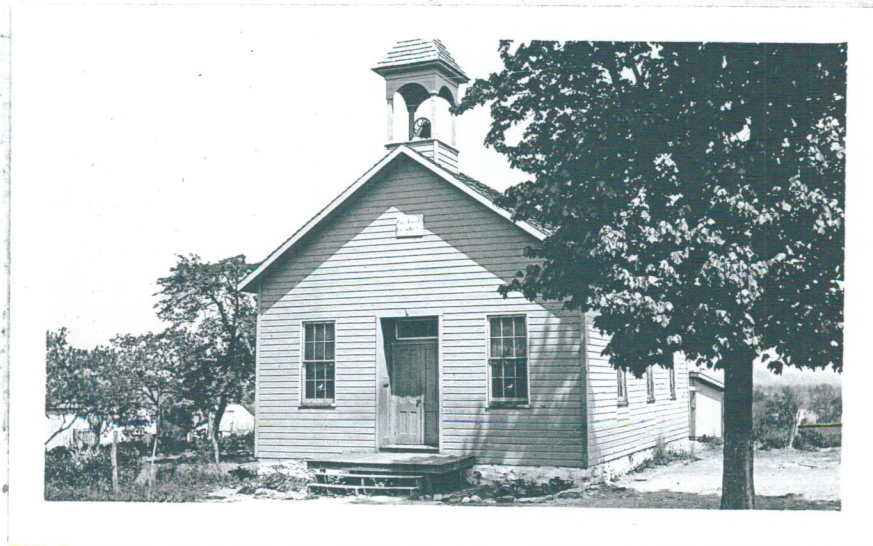
NO. 67 - BURKITTSVILLE (Colored)

DESCRIPTION: One story frame building on stone foundations with ordinary wood joist roof covered with wood shingle; floor of ordinary wood joist construction, with tongued and grooved wood sheathed ceiling and wood lath and plaster sidewalls.

Building is in a good state of repair and the estimated 100% insurable value is approximately \$1,000 after deducting cost of foundations and depreciation, while at the present time \$350 is carried on the building and \$90 on contents.

PROTECTION: This school is also located in Burkittsville District, beyond the limits of any recognized fire protection zone and the correct rate, therefore, is 70 cents building and contents.

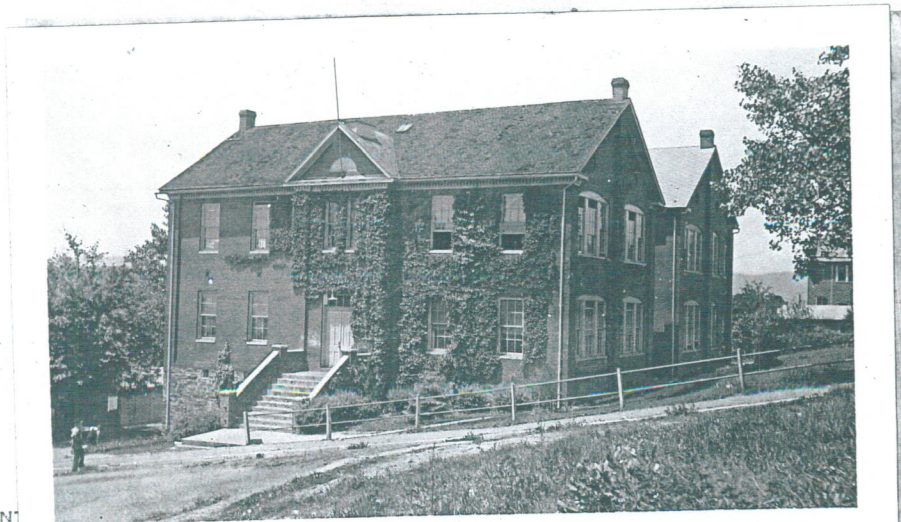
NO. 72 - WEST BRUNSWICK

DESCRIPTION: Two story brick building with an ordinary wood joist roof covered with metal; interior finish is of wood lath and plaster sidewalls with tongued and grooved wood sheathed ceiling. Floors are of ordinary wood joist construction, excepting the basement which has a concrete floor.

This building is old but in a good state of repair and the estimated 100% insurable value is approximately \$27,000 after deducting cost of foundations, excavations and depreciation, while at the present time \$20,250 is carried on the building and \$1,575 on contents.

A credit of 3 cents, however, can be obtained by the provision of two 2½ gallon chemical labelled extinguishers on each floor and basement, and a reduction of 4 cents in the contents rate can be had by applying the new differential now in effect.
